SERVICE BULLETIN

AMATEUR RADIO

| SUBJECT | DATE |
|---|---|
| TS-940S AVR UNIT CAPACITOR CHANGE | 4-8-86 |

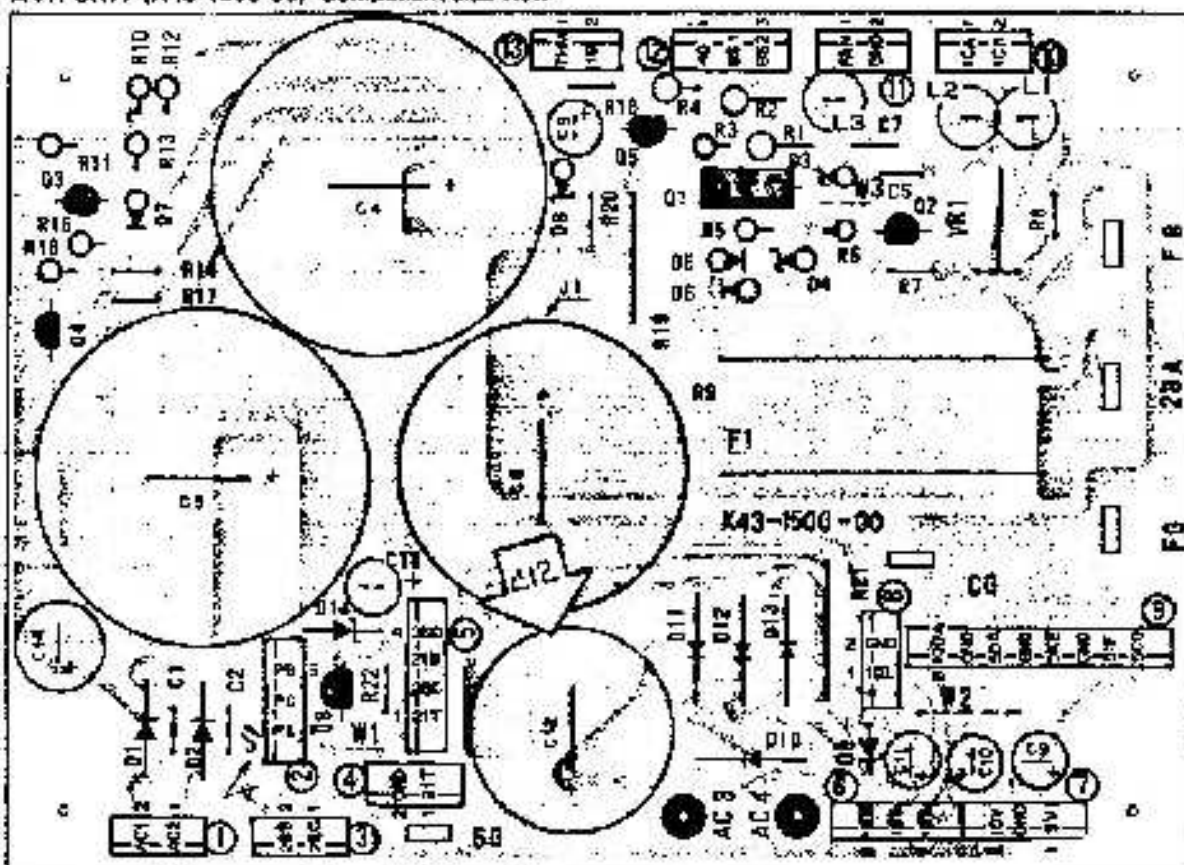
AVR UNIT (X43-1500-00) Component side view

In those areas of the country that are subject to large power line voltage fluctuations, excessive voltage may be applied to capacitor C12 on the AVR Unit (X43-1500-00). These voltage fluctuations might exceed the capacitor breakdown voltage. Replacing capacitor C12 with a capacitor having a higher breakdown voltage will help prevent this potential problem.

On the AVR Unit (X43-1500-00) change C12 from a 6800 μ F capacitor to a 5600 μ F 25 v capacitor (C98-2837-05).

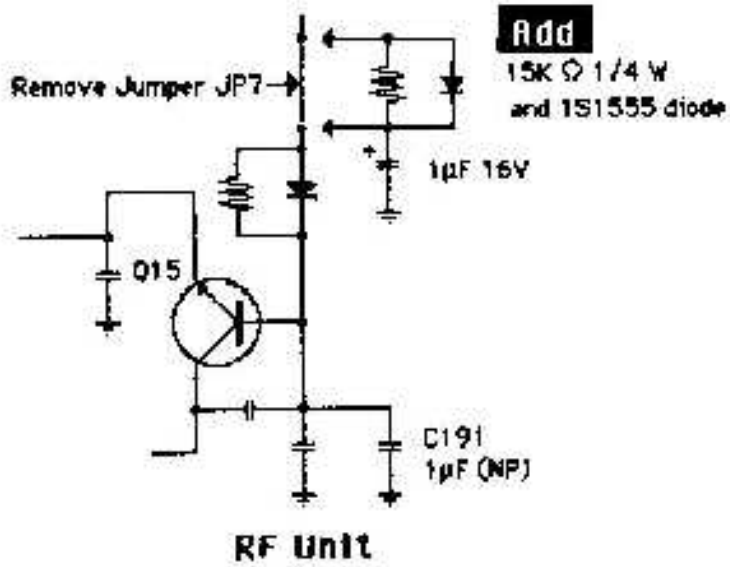
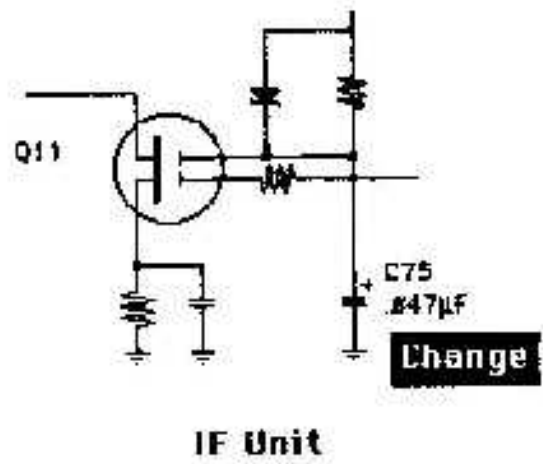
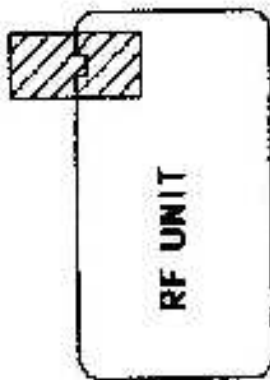
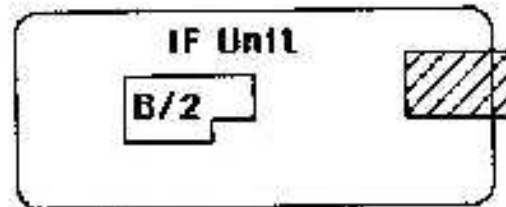
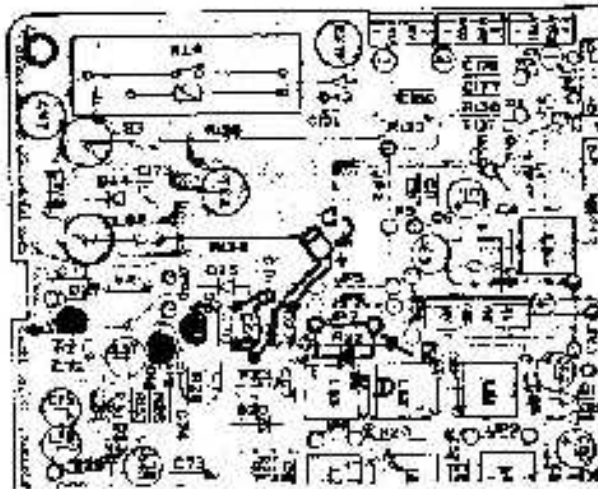
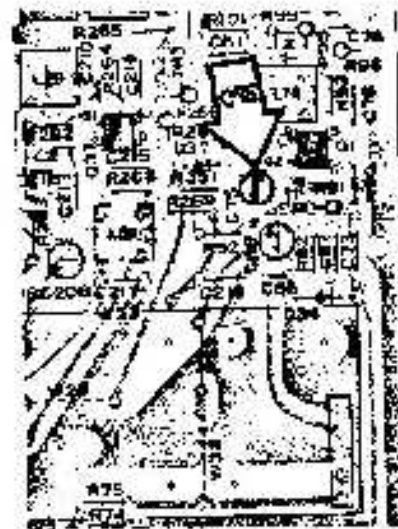
The following changes will improve the adjacent channel rejection of the TS-940S when a relatively strong nearby signal is present (S-4 or above).

1. Remove jumper wire JP7 and replace it with the parallel combination of the 15 k ohm resistor and the 1S1555 diode. Pay close attention to polarity.
2. Add the 1 uF capacitor as shown in the diagram.

Change capacitor C75 from a 1 uF 50 v capacitor to a .047 uF 50v capacitor.

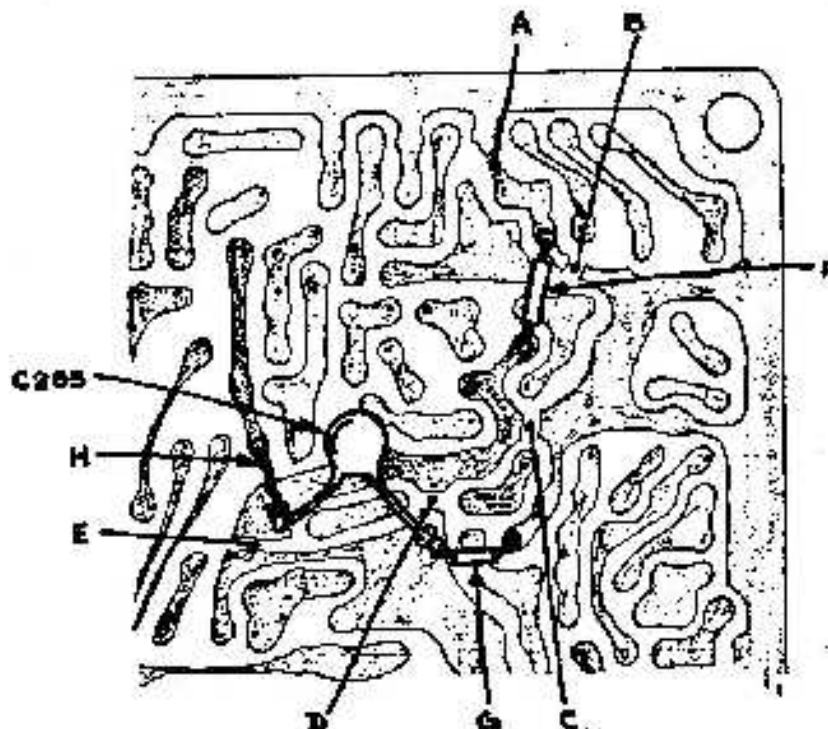
For reports of a low level audio hum superimposed on the normal transmitted audio, especially when the Speech Processor is used perform the following modification.

- Cut the foil patterns labeled A-E in figure 1.
- Add the jumper wires labeled F-H in figure 1.
- Add capacitor C285 .01 uF 50 v as shown.

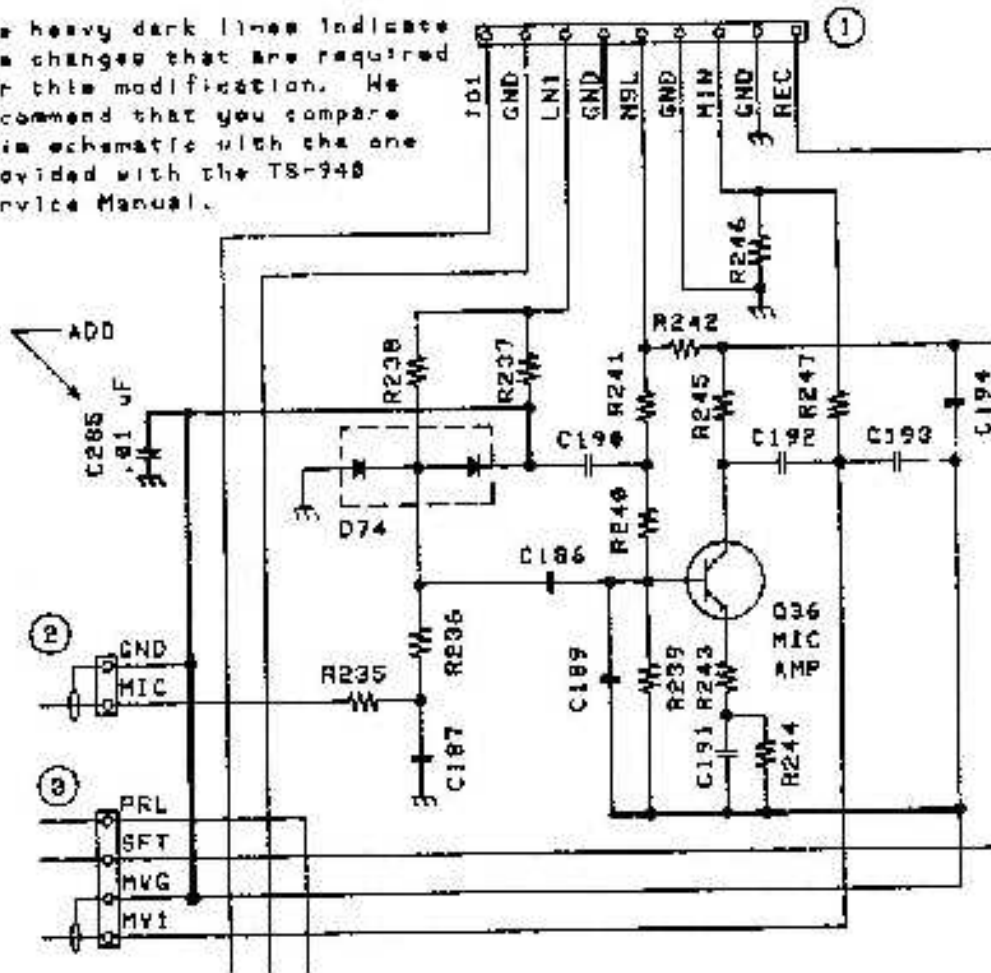
IF UNIT (X48-1430-00)

The heavy dark lines indicate the changes that are required for this modification. We recommend that you compare this schematic with the one provided with the TS-940 Service Manual.

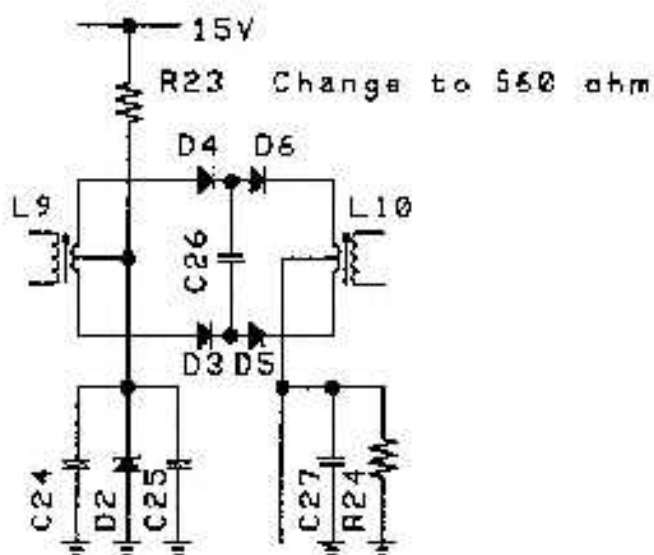
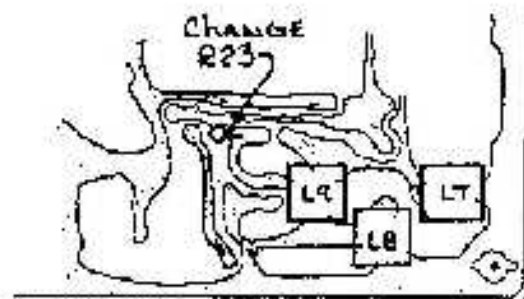
The following change will reduce the tendency of the Zener Diode in the Noise Blanker circuit to cause an increase in the ambient noise level. This change ensures that no current flows thru this diode in the normal receive position.

On the IF UNIT (X48-1430-00) change R23 from 330 ohms to 560 ohms.

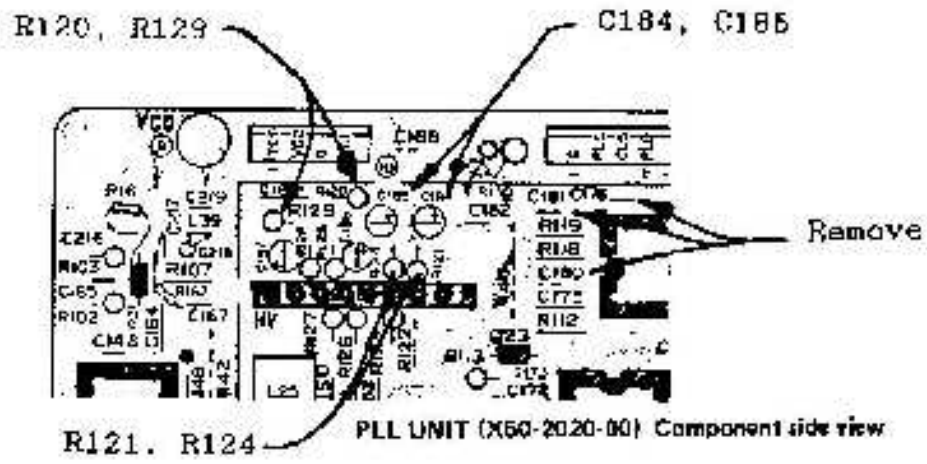
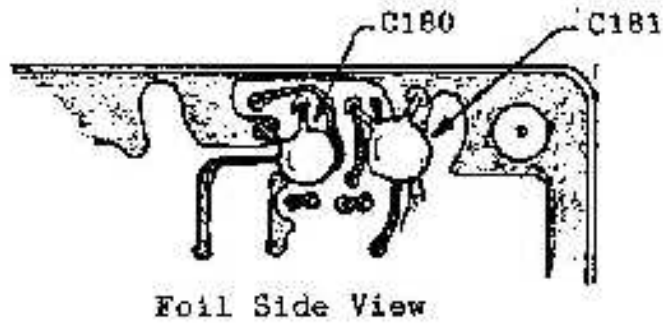
The Carrier to Noise ratio of the TS-940S may be improved by the following changes. This bulletin supersedes bulletin number 911 dated September 15, 1986.

On the PLL UNIT (X50-2020-00) remove capacitors C176, C180, and C181. Change resistors R120 and R129 from 470 ohms to 3.3 K ohms. Change resistors R121 and R124 from 1 K ohm to 680 ohms. Change capacitors C184 and C185 from .22 uF to .33 uF 35V tantalum capacitors. Install C180 and C181 in the positions shown in the accompanying diagrams. The use of new capacitors is recommended to improve reliability, don't try to reuse the old capacitors! Capacitors C181 and C180 should be attached to the foil side of the PLL unit.

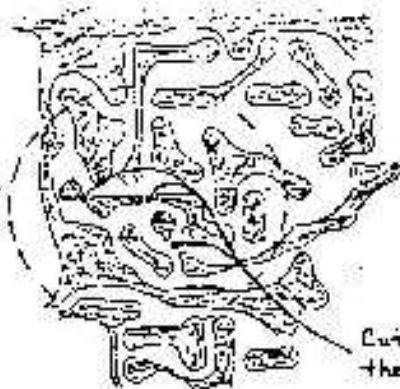
FIGURE 1

In some TS-940S below S/N 711xxxx, a "popping" or "clicking" noise may be heard when the squelch circuit is opened or closed. This may be more noticeable when an optional CW filter is installed. The following procedure will minimize the noise.

8. Using a small craft knife, cut the foil at the 3 points shown in figure 1 (top right corner of the board).
9. Unsolder and discard resistors R194 and R197. They are mounted on the component side of the board and soldered on the foil side.

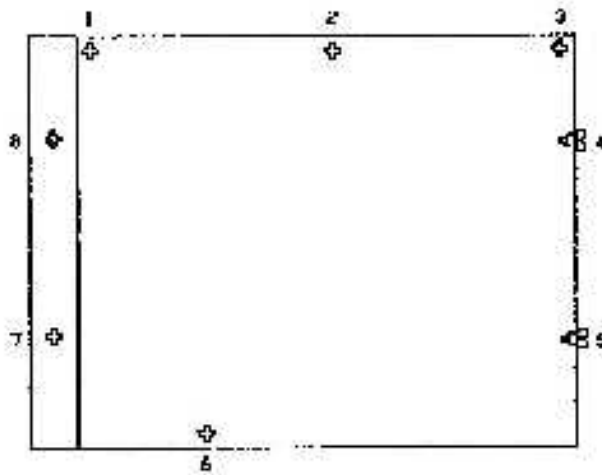
FIGURE 1

TS-940S in the serial number range of 601xxxx through 708xxxx may be limited in SSB peak power as compared to full CW output. The level may be increased by changing the value of capacitors C182 and C183 in the ALC circuit on the Control board. The recommended replacement value for each capacitor is 0.0022 uF, 50V (PART # CK45B1H222K).

4. Locate transistor Q37 on the board (toward the back right hand side). The two capacitors are mounted on the foil side of the board underneath Q37.
5. To access the bottom of the board remove the 8 screws that mount the board and heat sink to the chassis (See figure 1).

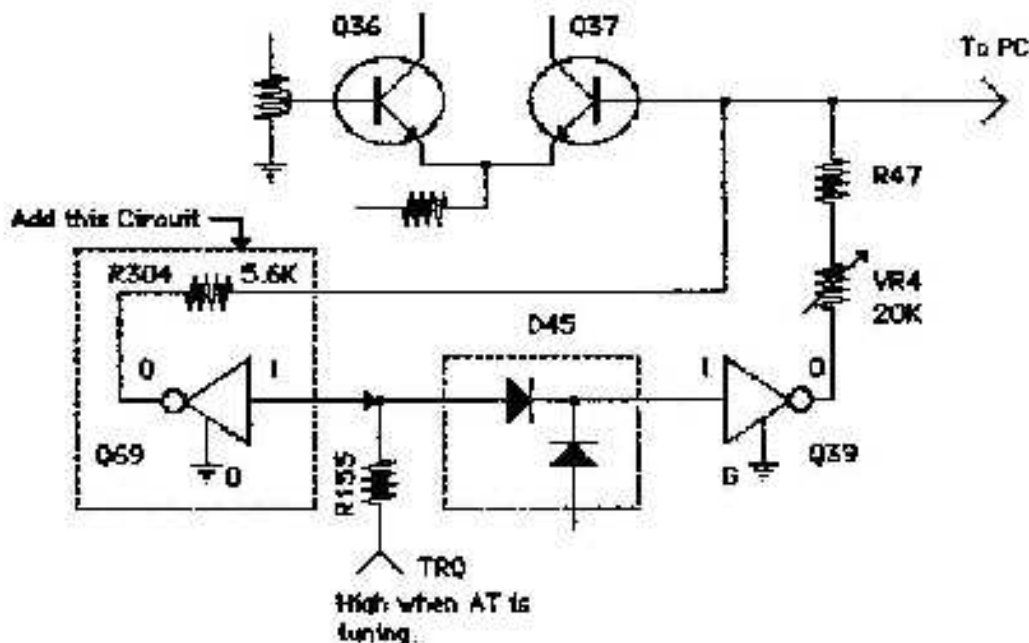
Occasionally during operation of the AT-940 a VSWR of greater than 1.5 to 1 might cause overloading of the relay contacts in the antenna tuner. This may be especially noticeable when switching BANDS, or if TUNING is performed too frequently. The following procedure should reduce or eliminate this tendency.

1. Add the circuit as shown below.
2. After the circuit has been installed adjust VR4 for a 10-15 watt output when the antenna tuner operates.

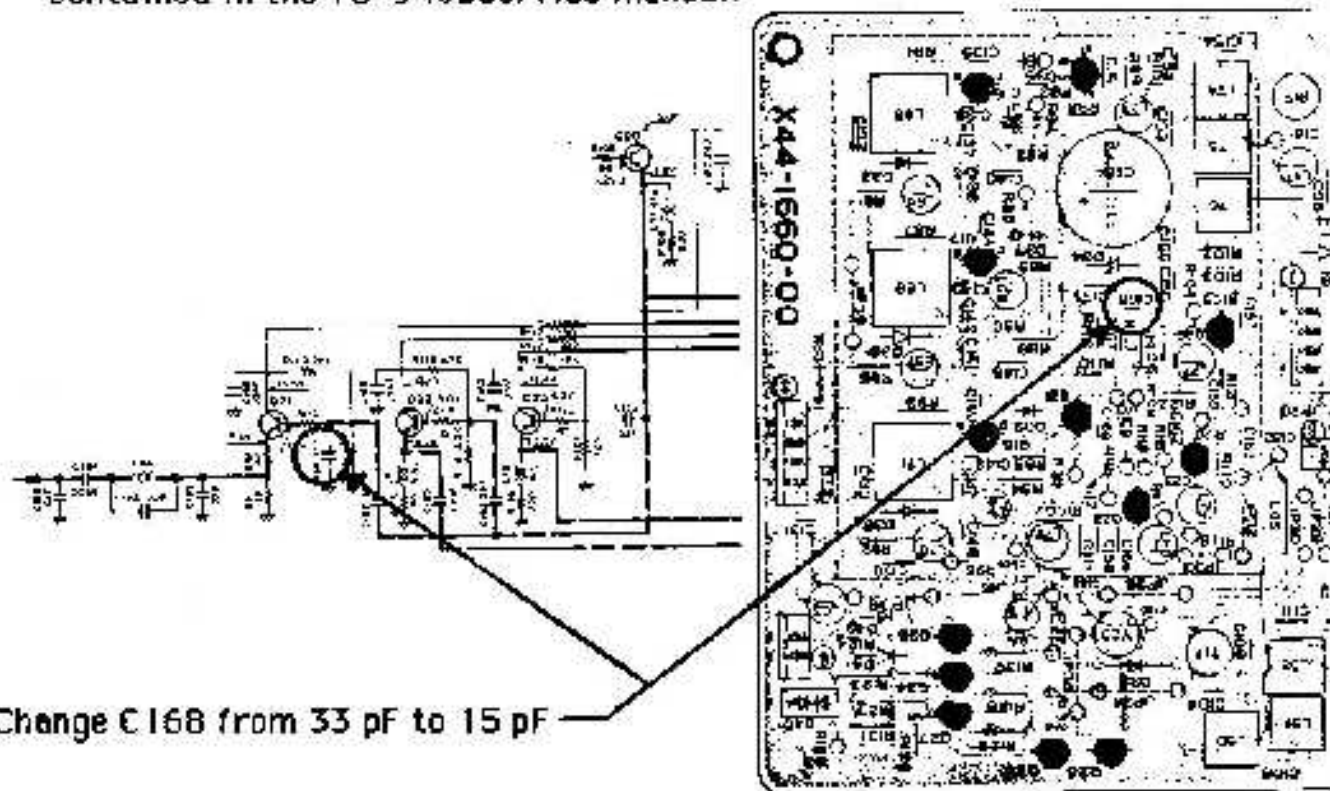
Reports of a PLL Unlock on the lower frequencies may be due to low VCO levels. The following change will increase the VCO level and should prevent recurrence of this symptom.

1. On the RF Unit (X44-1660-00) change C168 from a 33 pF capacitor to a 15 pF 50 v capacitor.
2. Readjust the VCO BPF (RF unit L74-76) according to the instructions contained in the TS-940S service manual.
