SERVICE BULLETIN

AMATEUR RADIO

| SUBJECT | DATE |
|---|---|
| TS-940S AVR UNIT CAPACITOR CHANGE | 4-8-86 |

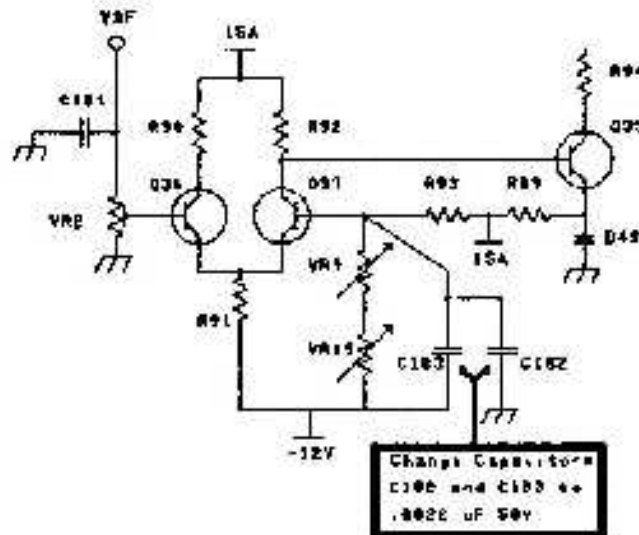
X53-1420-00
Control Unit

TS-940S in the serial number range of 601xxxx through 708xxxx may be limited in SSB peak power as compared to full CW output. The level may be increased by changing the value of capacitors C182 and C183 in the ALC circuit on the Control board. The recommended replacement value for each capacitor is 0.0022 uF, 50V (PART # CK45B1H222K).

6. Carefully lift the board/heat sink from the right hand side and pivot it toward the front of the transceiver.
7. Replace C182 and C183 with 0.0022 uF, 50V capacitors (see figure 2 for PC board view).

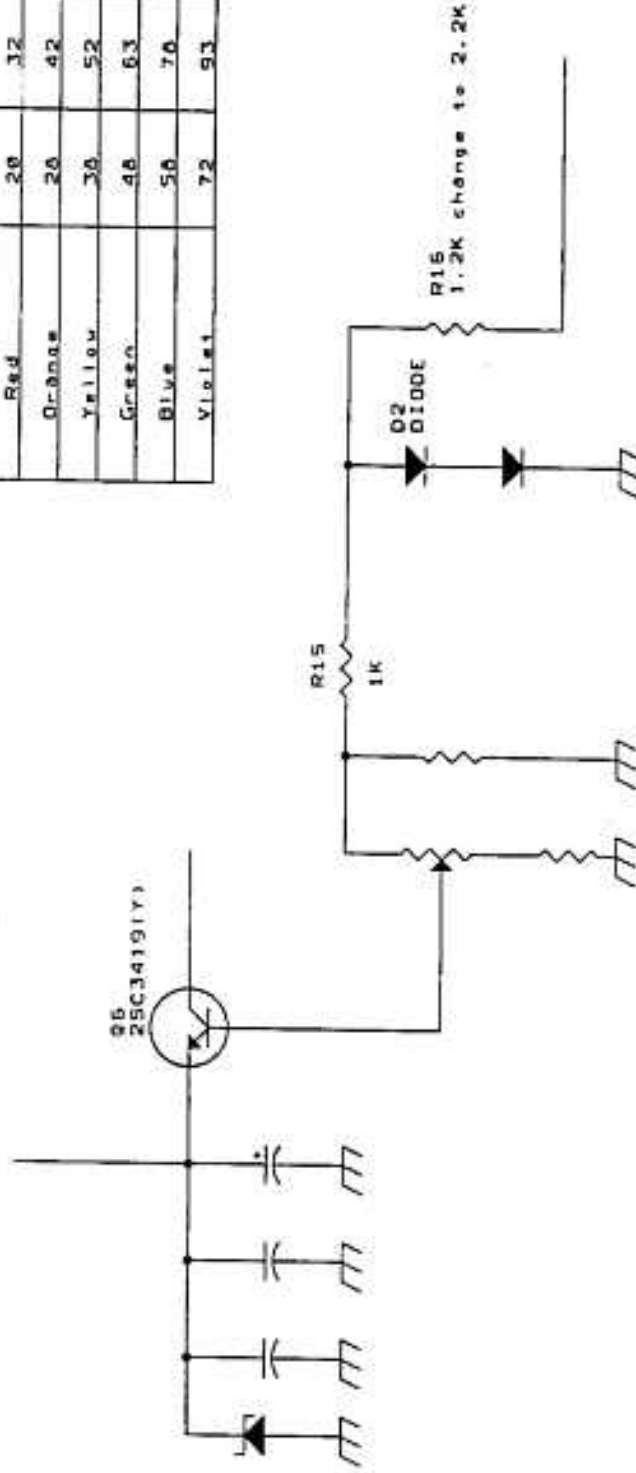
Title TS-0405 MRF-405 Driver Transistor

Some MRF-485 transistors are being supplied by Motorola with a Green or Blue color ranking. If these transistors are installed without modifying the driver bias circuit there is a very strong possibility that they will fail within a very short time frame.

These high gain transistors cause the circuit to become unstable which can cause the circuit to break into self oscillation, and therefore self-destruct.
